UNDERWATER BRIDGE INSPECTION REPORT

STRUCTURE NO. 56507

OTTER TAIL RIVER

DISTRICT 4 - OTTER TAIL COUNTY

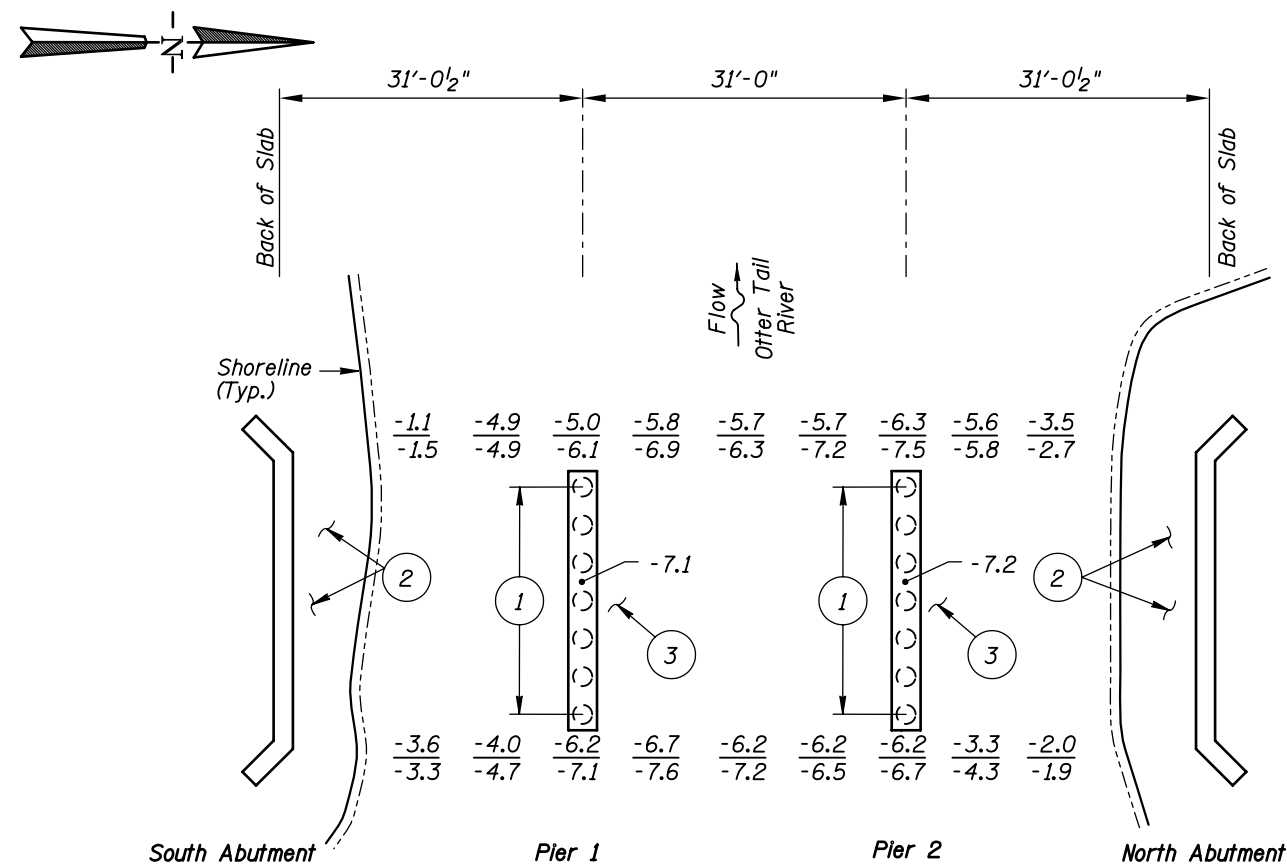
INSPECTION AND SOUNDING PLAN

- Overall, approximately 50 percent of the total submerged surface area of the steel pipe piles surfaces exhibited 100 percent coating failure and minor surface corrosion.
- 1 to 3 foot diameter riprap armored both shorelines.
- The channel bottom material consisted of gravel, sand, and random riprap with a probe rod penetration of 6 inches.

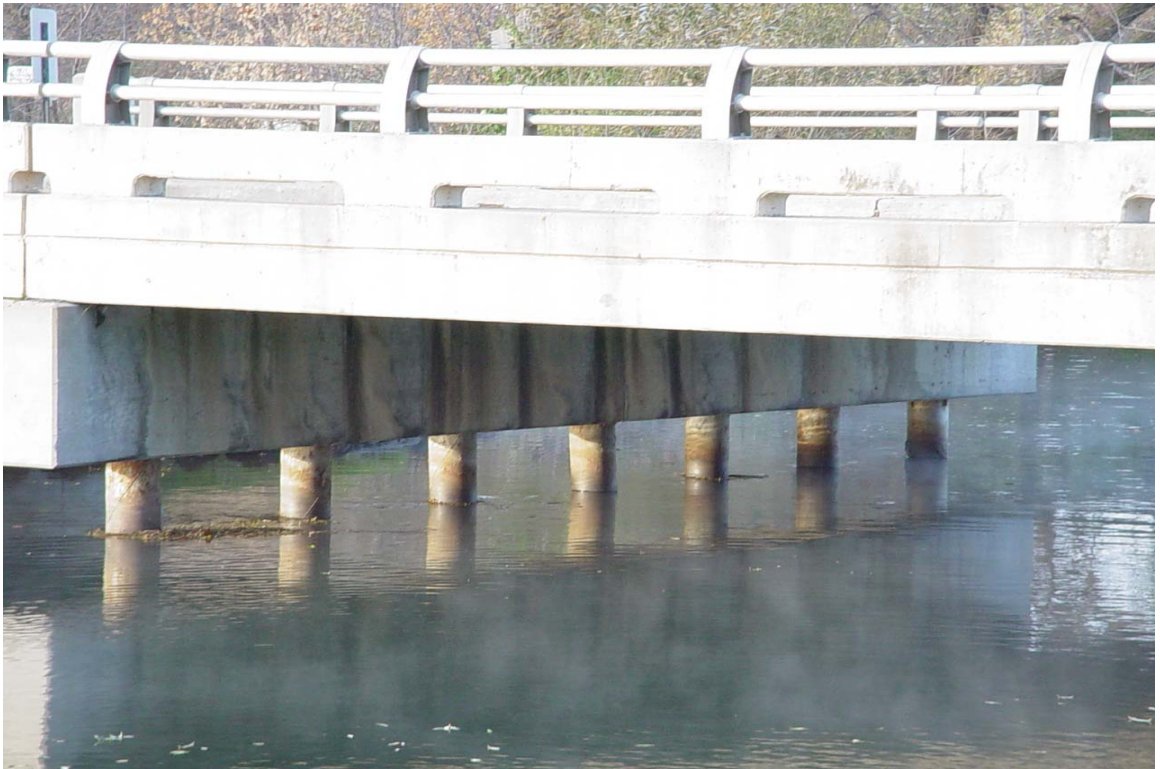
Photograph 2. View of Pier 1, Looking Southwest.

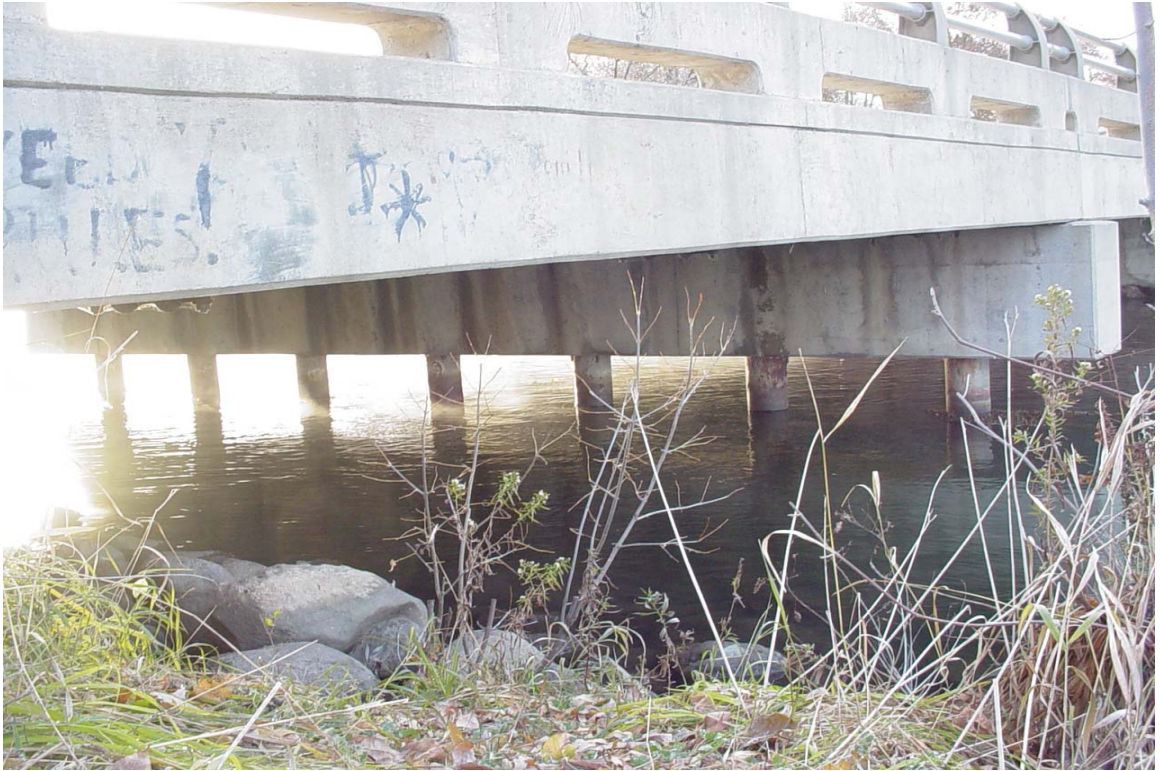
Photograph 3. View of Pier 2, Looking Southeast.
